## A VERY RARE SECTION OF FABRIC FROM A GERMAN AIRCRAFT CIRCA 1914

A very rare, early section of WW1 Fabric Cross from German Aircraft, measuring 64 x 52cms.

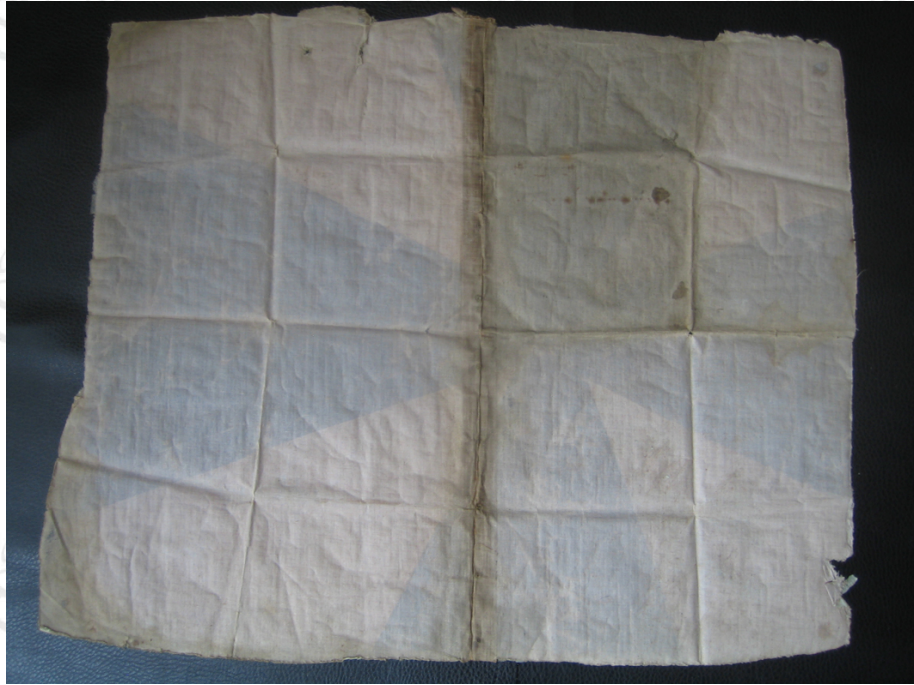
further with the graphics below in an effort to establish the probable original full size of the cross and probable position on the aircraft. I have used an LVG BI as an aircraft to base these graphics on. This is not because I'm sure its from this type but because it was one of the more common types used at the front at this time and similar styles of crosses can be found on photos of these aircraft (other types too). This aircraft is also a good 'average' sized two seater of the time as far as wing/fuselage dimensions, rib spacing etc are concerned.

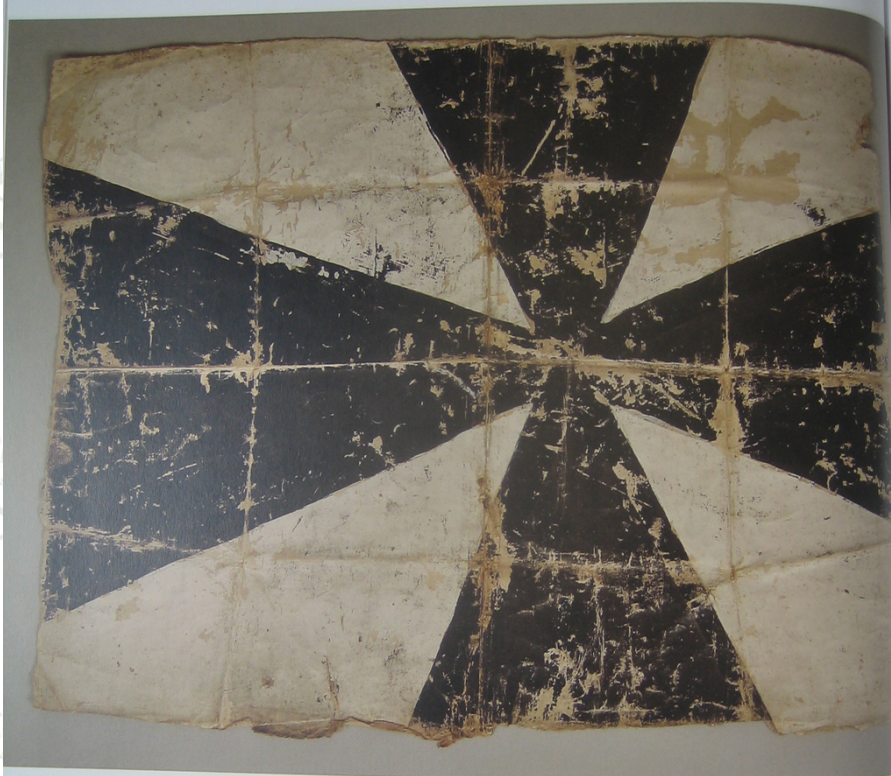
FELDZUG 1915 - VOLUME 2

The German Army Air Service was very small during peacetime, before the war, but rapidly expanded as its role became more apparent. The peacetime national markings consisted of a black stripe, from the leading edge, to the rear edge of the wing. The black Maltese Cross became the new wartime recognition insignia used from August 1914, initially there were no specific dimensions for the cross, or a hard and fast style, different aircraft manufactures chose to apply their own interpretations of this type of marking. Aircraft would sometimes have three different styles of Maltese Cross on the same plane, depending on the various sizes of stencils that they had, or the various ones that different painters had chosen to use.

airframe, was relatively fine in texture compared with linen used later in the war. Initially the black cross was painted directly onto the neutral coloured plain-doped fabric, this was found to be not conspicuous enough. It was then and probably still is, a fine line drawn between being able to be recognised by your own troops, for fear of accidents occurring, when at the same time trying to conceal yourself from an enemy. This fabric wing cross has had a white square, brush painted around it after the black cross had already been factory applied, which was most likely done by ground crew at an airfield to comply with the new regulations of September / October 1914.

the ribs, sometimes by sewing through the fabric onto an underlying rib tape that ran around the rib surface. The other main method used was to tack the top covering fabric to the ribs with small steel tacks, which was the way that was used for this cross. Whatever way it was done, a surface rib tape was doped on over the top, to cover and conceal the stitches or tack heads, making it less likely for the fabric to become loose in flight. The approximately one inch wide top rib tape can be seen in the photograph, as can the tack head marks that have worn through it, evenly spaced along its length. The uneven dimensions of the cross, are because it was originally much larger when in place on the aircraft, possibly cut off as the shape it is now, in its present size, it would have been easier to fold and keep in a service dress pocket. It may have been cut out and initially souvenired larger, at its full dimensions, with portions later cut off for others and sold or given away as souvenirs. The edge of the black cross has also been widened or re-touched, possibly due to flaking at some point during its service life.

On the back of the fabric, the long brown rib stain mark can be seen and as there is only one, it reveals that the ribs were spaced at a minimum distance apart, from the centre of the rib stain to the longest parallel edge of the cut fabric. In this case approximately 13 1/2", or 345mm, which means when using anthropology as a rough analogy, the bigger the gap between the ribs, the bigger the rib cage, i.e.; the bigger the animal or aircraft. Rib spacing of this size, leads me to assume that the aircraft that this cross was taken from was most likely a "B" type, an unarmed two seated reconnaissance bi-plane, the relatively low horse power of an early aircraft would mean that the wings would have had to have been sufficiently wide to carry the weight of two crew members. The view of the back also shows how the fabric was folded when souvenired, the two darker squares are dirtier, being the exposed outer sides of the folded cross. At this moment in time, I have not managed to determine exactly what design or make it is from, but have some possibilities that may, in the future, with more photographic evidence, prove to be fruitful in accomplishing this task.

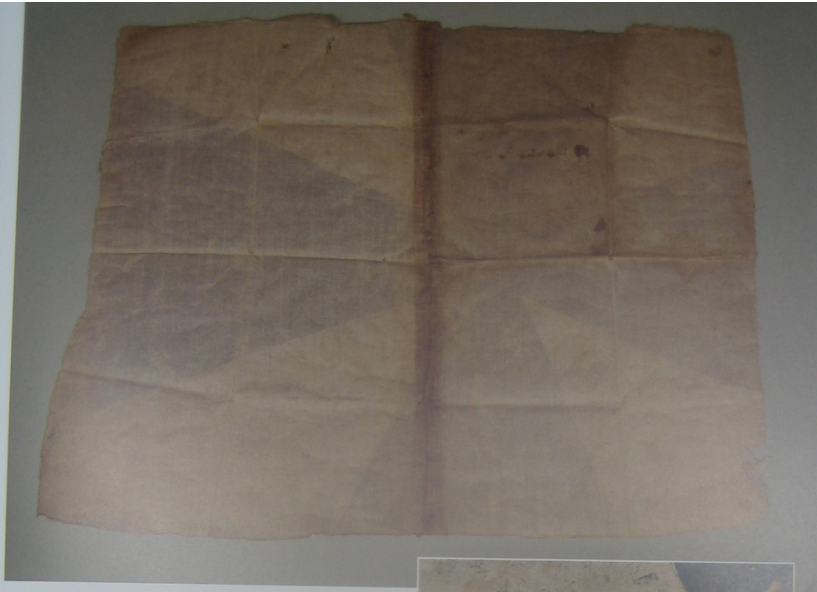
Fabric was attached to wings in various manners by different manufactures and for different types of model, sometimes by the same manufacturer. When the fabric was stretched over the wing frame and sewn on by hand, it was also affixed to
